Eagles Eye Home Inspection

HOME INSPECTION REPORT

Overview: Standard home inspection of a single family dwelling.

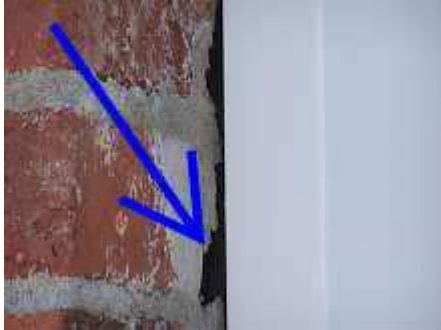
Photo 7

**4)** Caulk is missing or deteriorated in some areas. Recommend caulking where necessary. Need clear caulk around all windows and around garage door.

Caulk gaps around garage door with clear caulk.

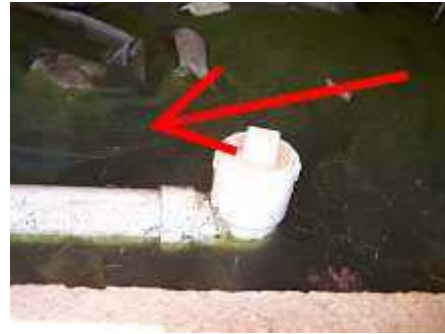
Photo 20

3" to 4" of water at this area.

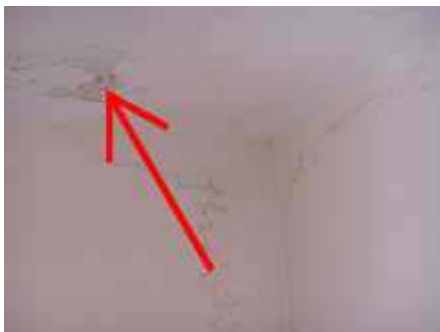
Photo 28

21) Water stains visible in ceiling, apparently or possibly from an active/previous leak from a plumbing pipe or jetted tub/shower. Recommend asking seller if leak was repaired. Recommend removing wet wallboard or plaster and replacing with new after area has dried thoroughly. Recommend doing a mold test on home.

Recommend doing a swab mold test and air sample test inside home. See other pictures.

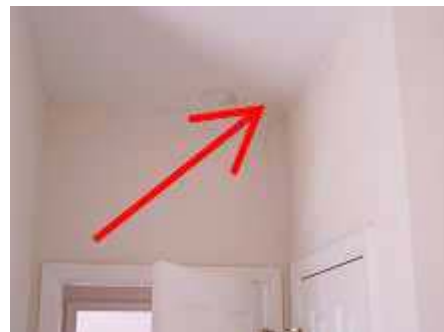
Photo 29

Water stains

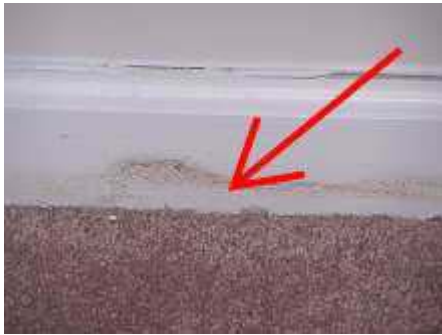
Photo 33
Water stain on base board.

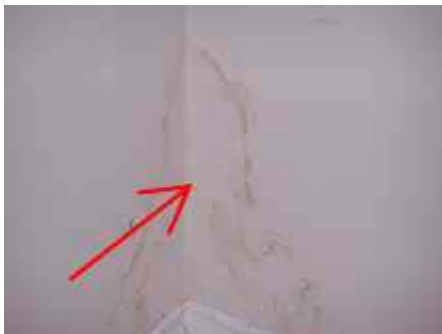
Photo 35
Water stain

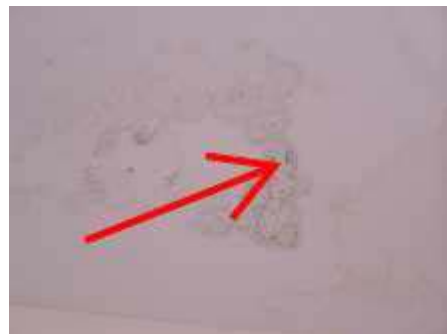
Photo 41

Ceiling patched. Might be due to a previous/active plumbing leak.

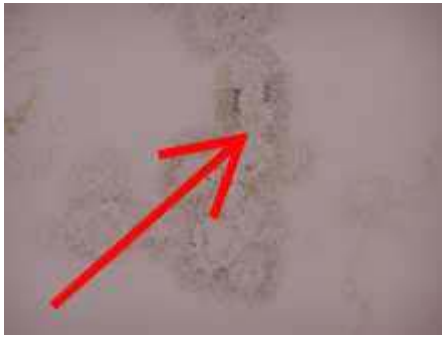
Photo 42

Recommend doing a mold swab test on this spot.

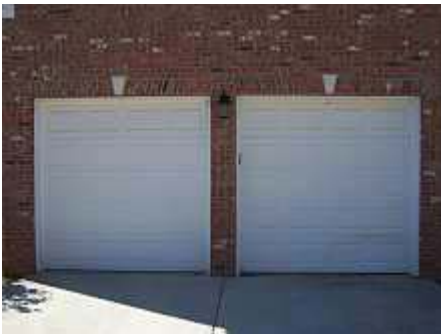
Photo 9

Caulk gaps around both garage door with clear silicone caulk.

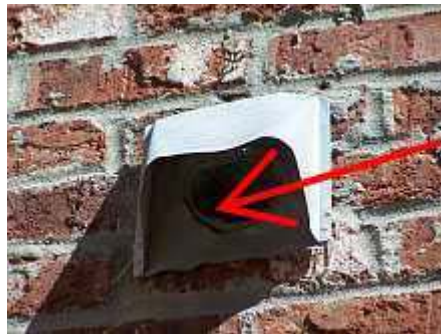
Photo 10

No vent cover installed.

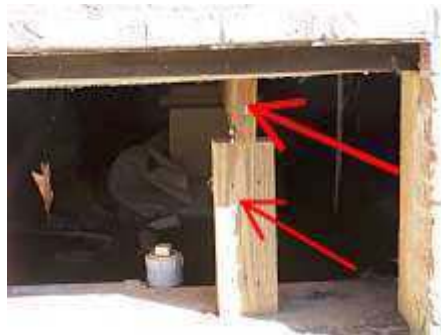
Photo 22

Wood bracing sub floor.

Joist could have been installed better and joist braced incorrectly with a wood block at entrance door. No crawl space door installed.

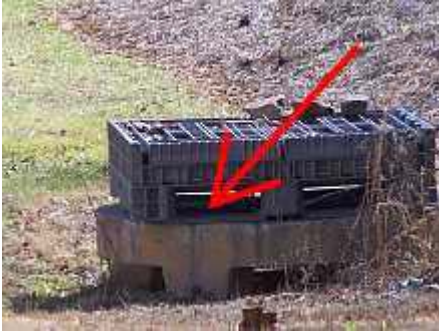
Photo 23
Storm drain

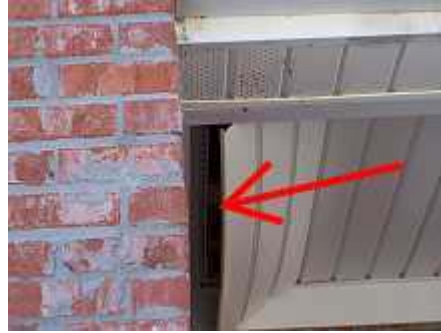
Photo 24
Siding coming loose on front porch.

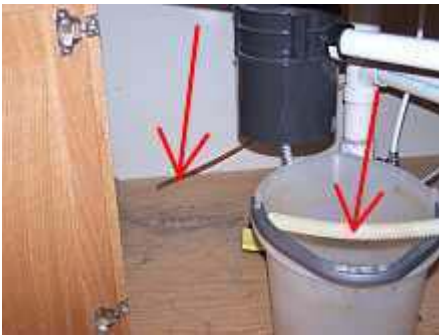
Photo 32
Dishwasher line not attached

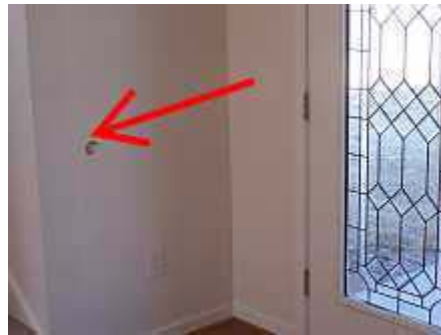
Photo 38
Hole in wall from front door. No door stopper installed.

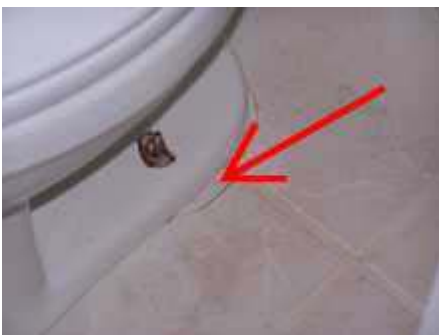
Photo 40
Tile cracked around toilet near floor.
